DEPARTMENT OF TRANSPORTATION**DIVISION OF ENGINEERING SERVICES**

Contract #: 04-0120F4Cty: SF/ALA Rte: 80 PM: 13.2/13.9File #: 69.28**WELDING INSPECTION REPORT****Resident Engineer:**Pursell, Gary**Address:** 333 Burma Road**City:** Oakland, CA 94607**Report No:** WIR-001028**Date Inspected:** 17-Dec-2007**Project Name:** SAS Superstructure**OSM Arrival Time:** 630**Prime Contractor:** American Bridge/Fluor Enterprises, a JV**OSM Departure Time:** 1530**Contractor:** Zhenhua Port Machinery Company, Ltd (ZPMC), Changxing Island **Location:** Shanghai, China

CWI Name:	N/A	CWI Present:	Yes	No			
Inspected CWI report:	Yes	No	N/A	Rod Oven in Use:	Yes	No	N/A
Electrode to specification:	Yes	No	N/A	Weld Procedures Followed:	Yes	No	N/A
Qualified Welders:	Yes	No	N/A	Verified Joint Fit-up:	Yes	No	N/A
Approved Drawings:	Yes	No	N/A	Approved WPS:	Yes	No	N/A
				Delayed / Cancelled:	Yes	No	N/A
Bridge No:	34-0006	Component:	114m Mock-ups, 89m Skin's E and D

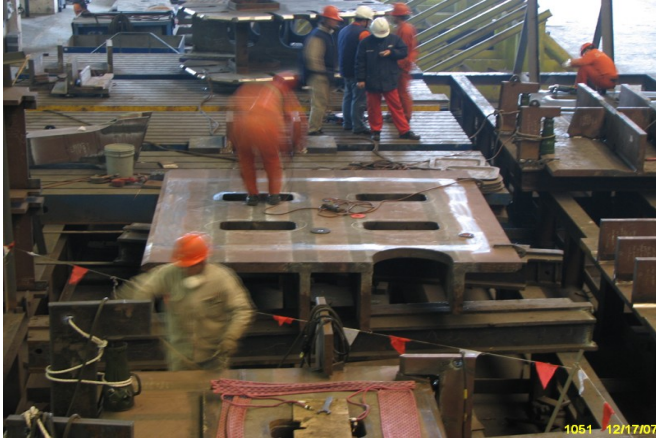
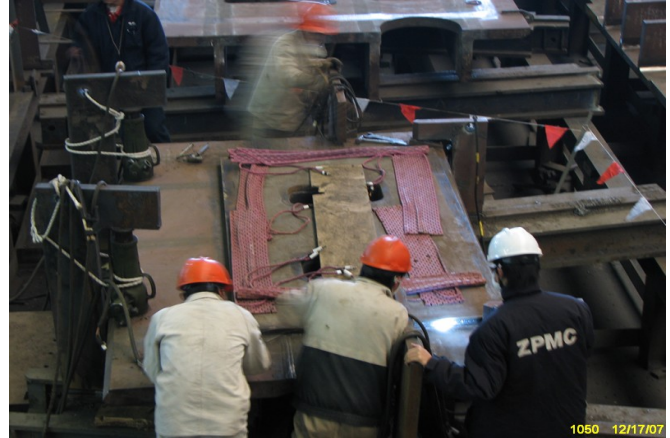
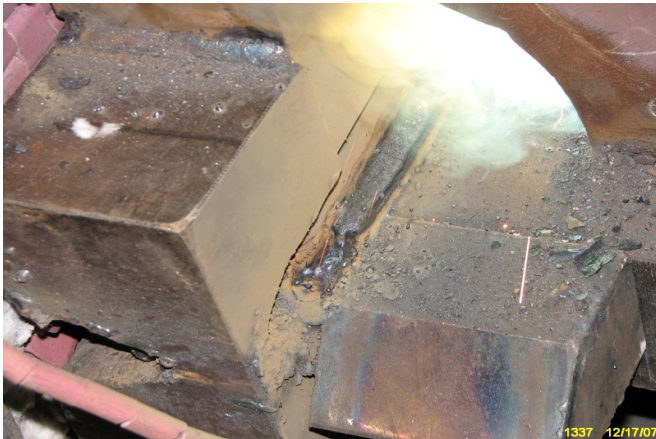
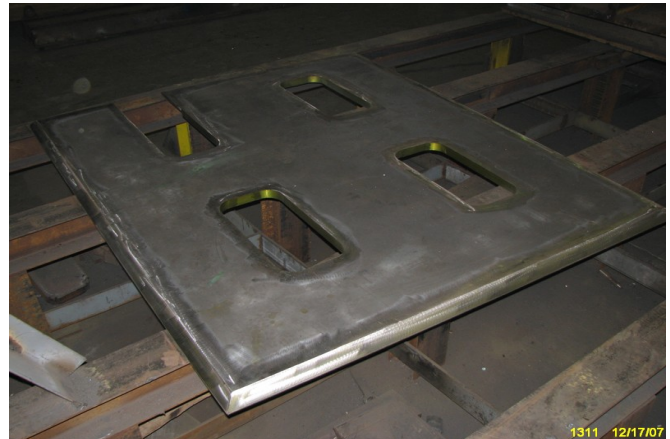
114m upper and lower section were again rotated. ZPMC performed dimensional analysis following the rotation of the assembly. The 114m upper section - Sub Arc Weld (SAW) welders are establishing welder parameters. The fit-up awaiting welding operations was not cleaned. ZPMC and Bureau Veritas inspectors agreed and the problem was rectified. The weld joint and surrounding area was ground to bright metal. Preheating was reestablished with ceramic heater blanket.

89m- Skin E- MA38 to SA215 welds 1,2,3 and 4 were still in process for weld joint #MUB-MA21 B/J.

89m- Skin A- MA21 to SA214 for joint # MUB-MA21-C/J each area on the plate faces has been cleaned using a mechanical grinder in order to removed the oxidation in preparation for thermal operations. No fit-up has been observed.

114m lower- Welder is having difficulty making the start of his weld onto the run-off tab. Due to the temporary diaphragm being recessed 50mm into the interior of the mock-up, the welder is sticking his FCAW welding tip out through an access hole at the weld joint. He has extensive stick-out and is out of position from what appeared to be

100-20mm out at the start of this Complete Joint Penetration (CJP) weld.

Electrode Storage Room- The weld issue logs are still written in Chinese characters after several attempts to rectify them. Temperatures appear to be within parameters for electrode and flux storage only. No drying temperatures have been observed.
